### Arboricultural Inspection

<b>Site Name:</b>	Elizabeth Road Play Area and Playing Fields
<b>Address:</b>	Elizabeth Way, Seaton, EX12 2DT
<b>Reference no.</b>	JG/B168/0122/ELI
<b>Client:</b>	Seaton Town Council
<b>Date of site visit:</b>	6 <sup>th</sup> January 2022
<b>Inspector:</b>	Joel Gray FdSc (Arb), NCF Arb, Cert Arb (ABC, RFS), MArborA
<b>Weather:</b>	Inclement and windy

<b>Site Name:</b>	Seaton Down Hill Picnic Area
<b>Address:</b>	Seaton Down Hill, Seaton
<b>Reference no.</b>	JG/B168/0122/SDH
<b>Client:</b>	Seaton Town Council
<b>Date of site visit:</b>	6th December 2022
<b>Inspector:</b>	Joel Gray FdSc (Arb), NCF Arb, Cert Arb (ABC, RFS), MArborA
<b>Weather:</b>	Inclement and windy

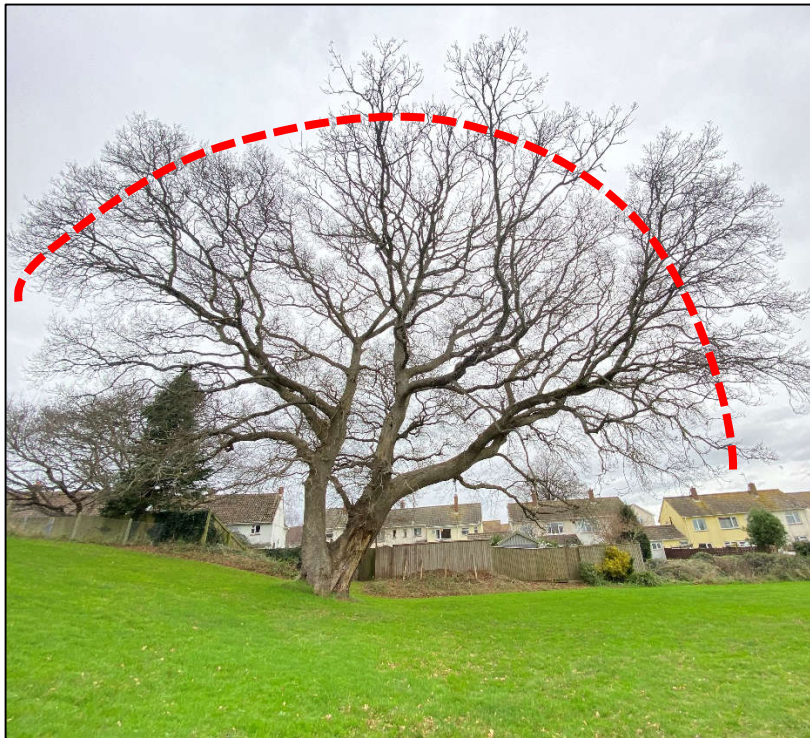
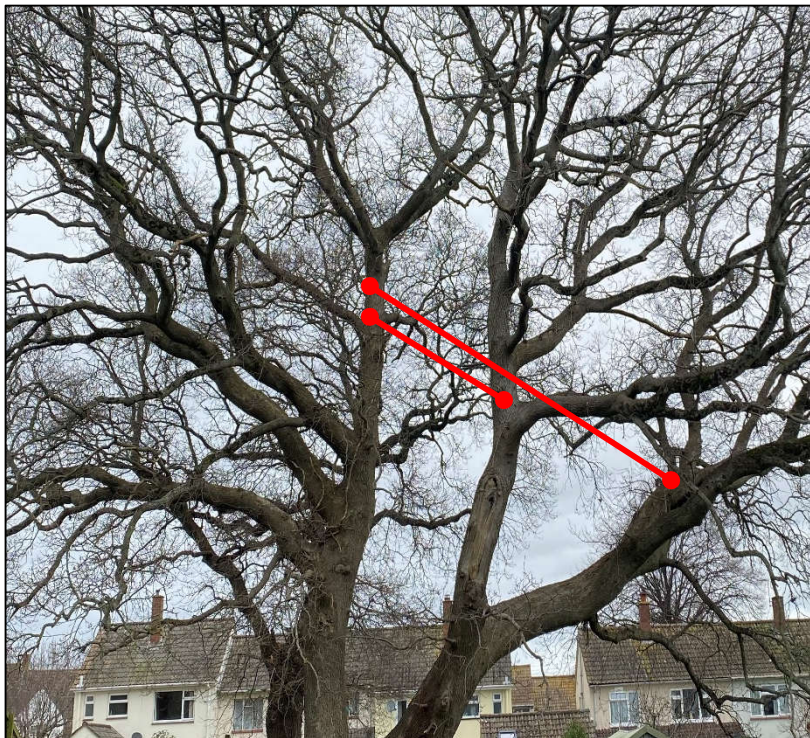
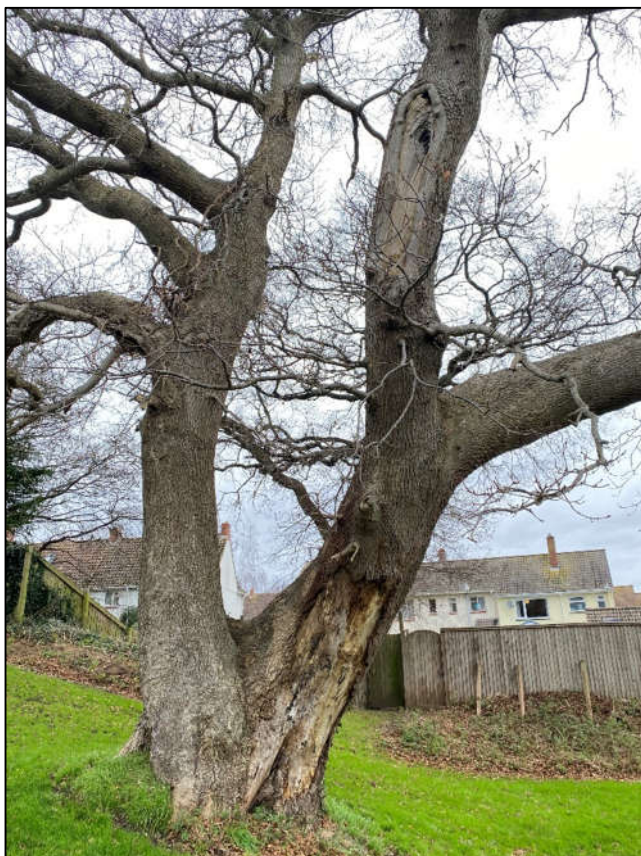
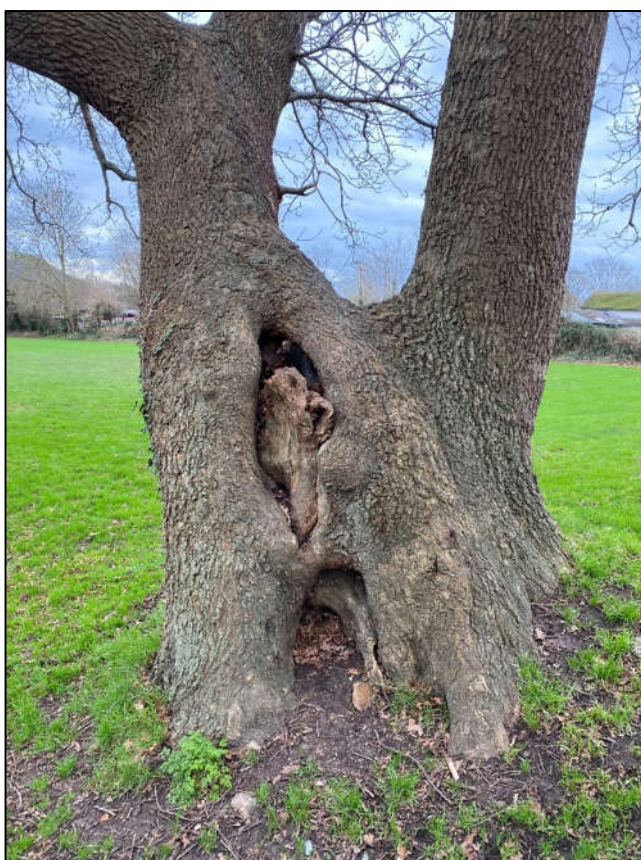
<b>Tree Number:</b>	1508	<b>Species:</b>	Oak
<b>Age Range:</b>	Mature	<b>Height:</b>	High
<b>Life Expectancy:</b>	Medium	<b>Tree Condition:</b>	Fair
<b>Site Features:</b>	Tree located in playing field with goal posts in failure distance		
<b>Comments:</b>	<ul style="list-style-type: none"> <li>• Large mature Oak specimen with two dominant leading stems, bifurcating at 1.5m above ground level</li> <li>• Eastern stem with significant eastern bias and evidence of historic southern aspect branch failure</li> <li>• Bark and cambium death from ground level to approximately 2.0m on eastern-most stem, with associated vascular dysfunction manifesting as lower crown density in the central upper canopy</li> <li>• Sounding mallet reveals diminished wood density</li> <li>• Metal probe inspection confirming the wood is solid, with minimal soft decay</li> <li>• Wound-wood appears on outer edges of parts of the dysfunction</li> <li>• Northern side of the crown break, opposite the southern and eastern cambium death, hosts two connecting open cavities with good amounts of wound wood present</li> </ul>

<b>Hazard Rating:</b>	Medium		
<b>Recommendations:</b>	<ul style="list-style-type: none"> <li>• Reduce eastern canopy by 2.0-3.0m with maximum diameter cuts of 100mm. Indicative reduction extent as illustrated in attached photograph</li> <li>• Reduce remaining canopy by 1.0m to match eastern canopy, maximum diameter of cuts 60mm. Indicative reduction extent as illustrated in attached photograph</li> <li>• Install two flexible braces rated to 8 tonnes from central stem to two eastern stems. Indicative location of braces as illustrated in attached photograph</li> </ul>		
<b>Works Priority:</b>	3

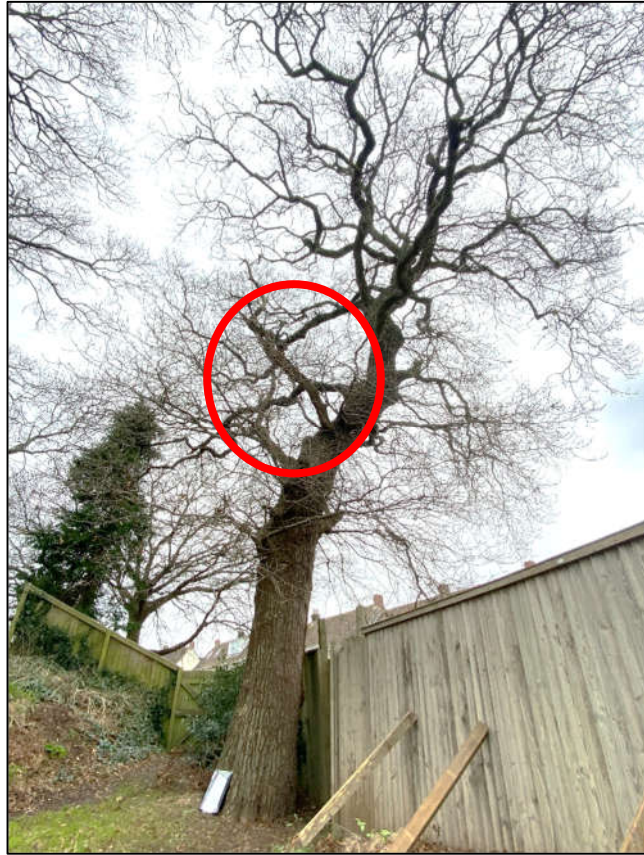
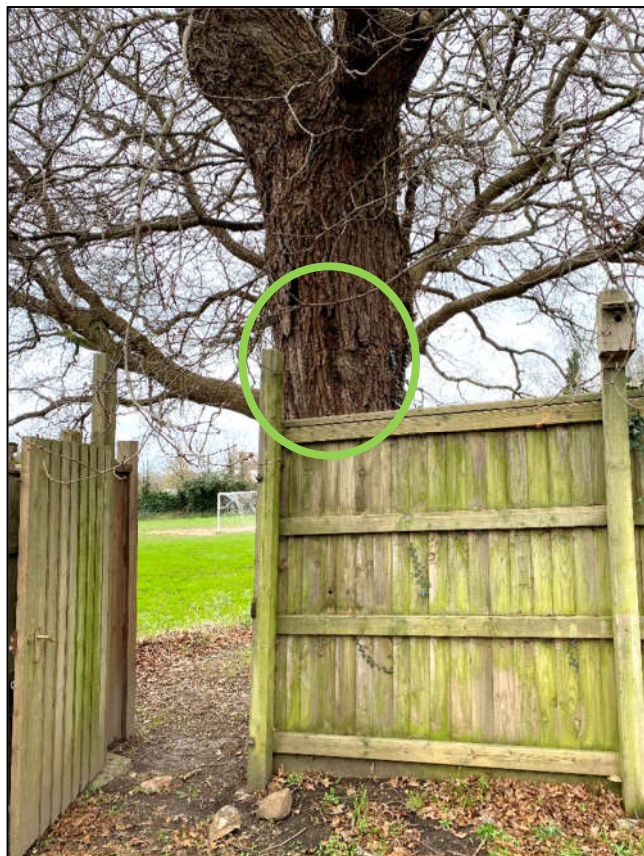
<b>Tree Number:</b>	1509	<b>Species:</b>	Oak
<b>Age Range:</b>	Mature	<b>Height:</b>	Medium
<b>Life Expectancy:</b>	High	<b>Tree Condition:</b>	Fair
<b>Site Features:</b>	Tree overhangs neighbouring garden and two rear garden gates		
<b>Comments:</b>	<ul style="list-style-type: none"> <li>• Maturing specimen with a stem and crown bias north-east</li> <li>• Evidence of large northern limbs historically removed</li> <li>• Major deadwood within the crown and overhanging garden exit route. Red circle in attached photograph indicates this</li> <li>• Historic bark dysfunction with evidence of loose bark on northern aspect of main stem from near ground level to approximately 2.0m above ground level; appears to have fully enclosed with wound wood, but flaking bark still present. Green circle in attached photograph indicates this</li> <li>• Significant epicormic growth overhanging and low into neighbouring garden and over fence</li> </ul>

<b>Hazard Rating:</b>	Low		
<b>Recommendations:</b>	<ul style="list-style-type: none"> <li>• Remove major deadwood from within the crown</li> <li>• Remove low and overhanging epicormic growth which is within 0.5m of neighbouring fence and gate. Maximum diameter of cuts 50mm</li> <li>• Resi-drill inspection of mainstem where bark dysfunction is located</li> </ul>		
<b>Works Priority:</b>	4

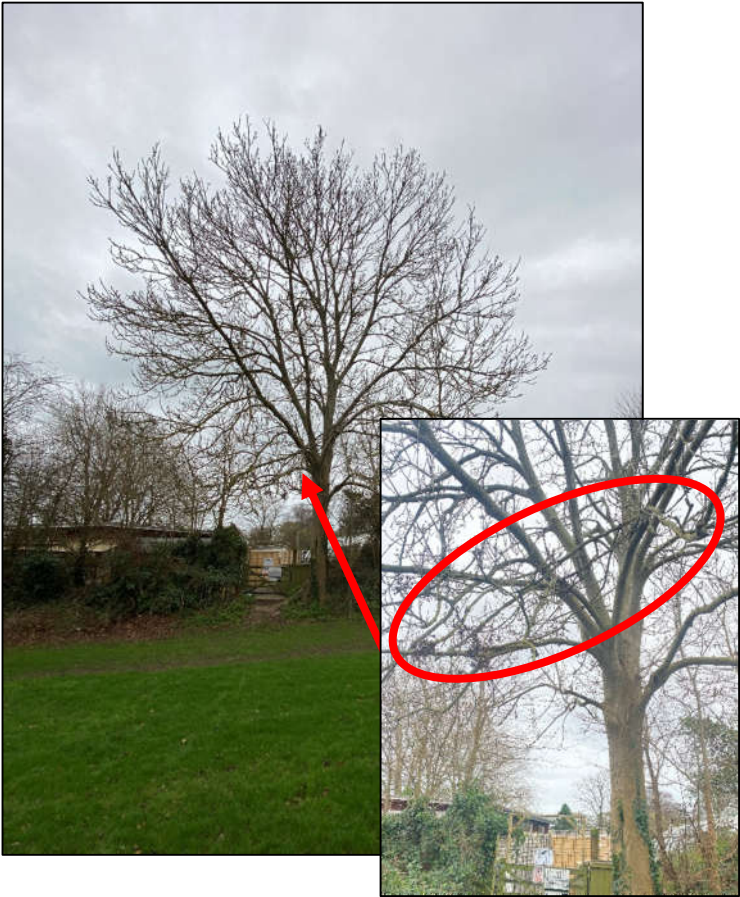
<b>Tree Number:</b>	1510	<b>Species:</b>	Ash
<b>Age Range:</b>	Middle Aged	<b>Height:</b>	Medium
<b>Life Expectancy:</b>	Low	<b>Tree Condition:</b>	Fair
<b>Site Features:</b>	Tree overhangs school entrance to playing fields		
<b>Comments:</b>	<ul style="list-style-type: none"> <li>• Single Ash stem on remnant hedge boundary adjacent school entrance to playing fields</li> <li>• Tree exhibits evidence of ADD vertical stress growth within inner crown</li> <li>• Split and hanging limb overhanging school entrance gate to field</li> </ul>		
<b>Hazard Rating:</b>	Medium		
<b>Recommendations:</b>	Remove hanging branch and re-inspect tree in summer 2022		
<b>Works Priority:</b>	4		
<b>Photograph:</b>

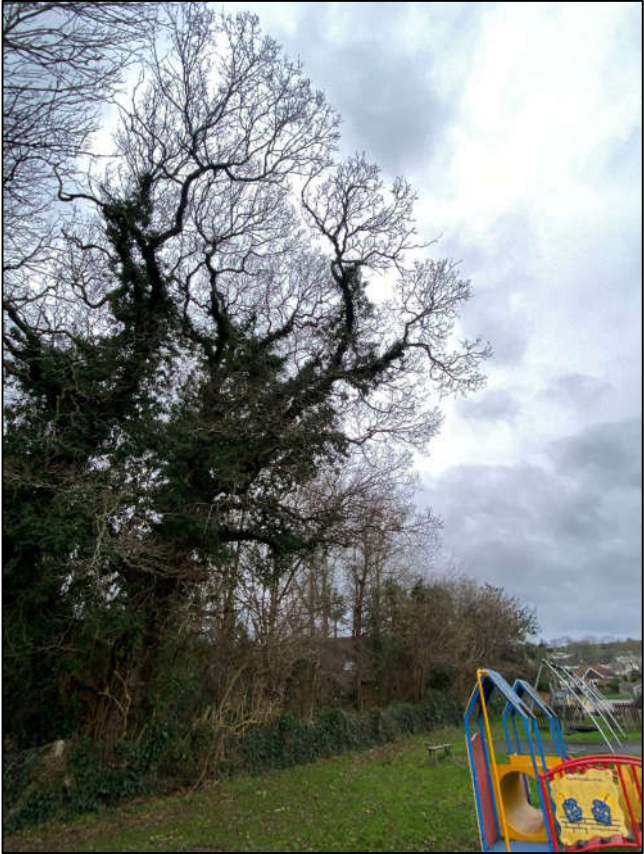
<b>Tree Number:</b>	Area A1	<b>Species:</b>	Mixed
<b>Age Range:</b>	Young - Mature	<b>Height:</b>	Medium - High
<b>Life Expectancy:</b>	Low - High	<b>Tree Condition:</b>	Poor - Good
<b>Site Features:</b>	Trees overhang children's play area		
<b>Comments:</b>	<ul style="list-style-type: none"><li>• Multiple neighbouring trees overhanging play area to the north</li><li>• Large mature Oak specimen with significant Ivy coverage hosts dead branch over children's play equipment</li><li>• Large Ash within area overhanging play area and is exhibiting signs of ADD</li><li>• Significant Ivy coverage impeding visual inspection of multiple stems from a distance</li></ul>		
<b>Hazard Rating:</b>	Medium		
<b>Recommendations:</b>	Inform tree owner and advise a professional arboricultural safety inspection		
<b>Works Priority:</b>	3		
<b>Photograph:</b>

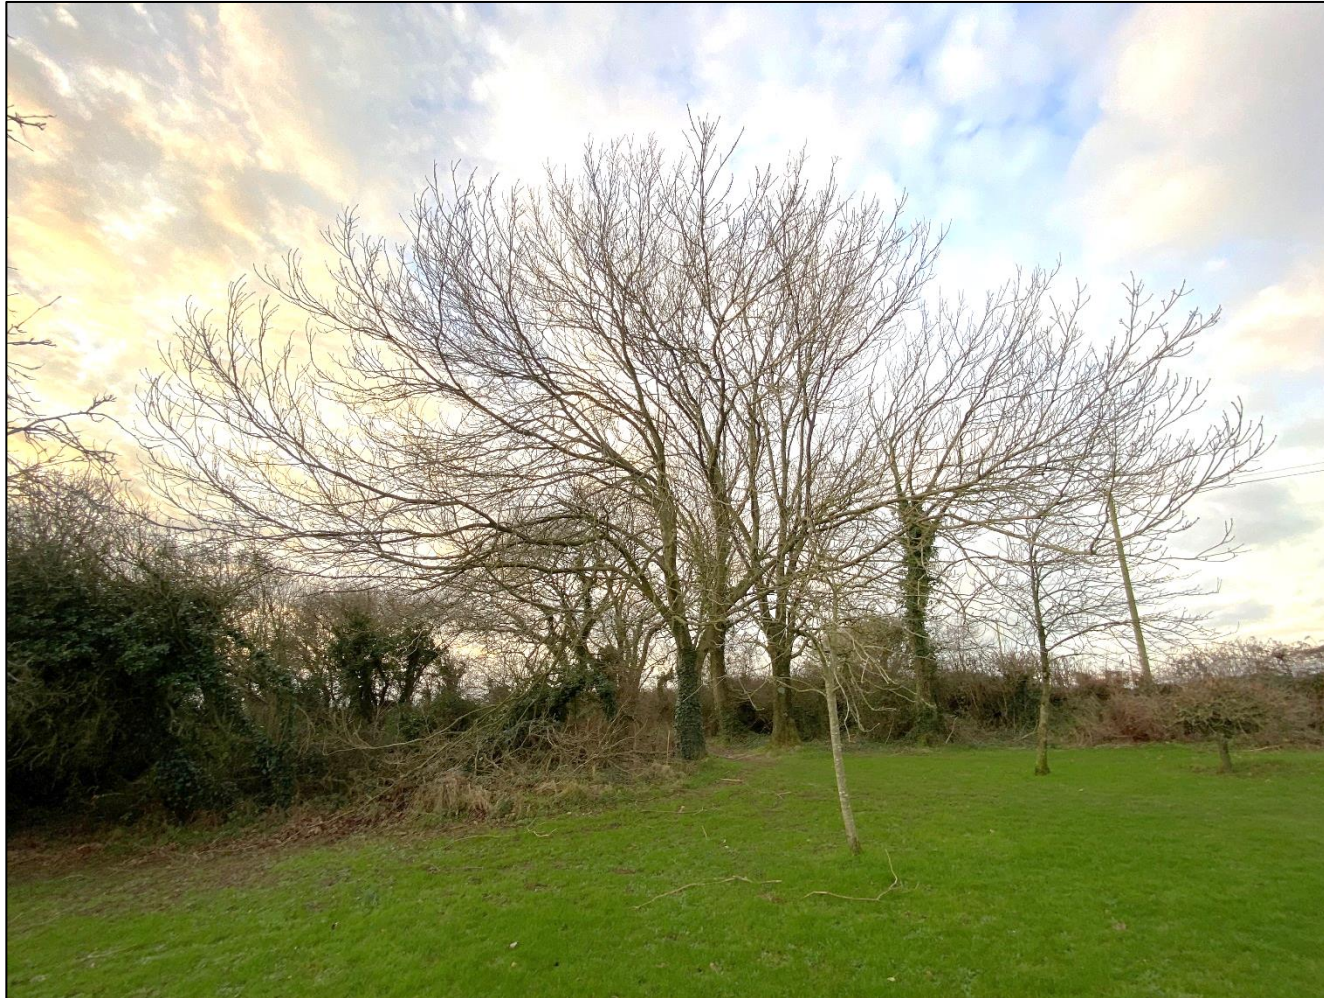
Photograph 1 – Looking south-west towards the southernmost area of Ash stems

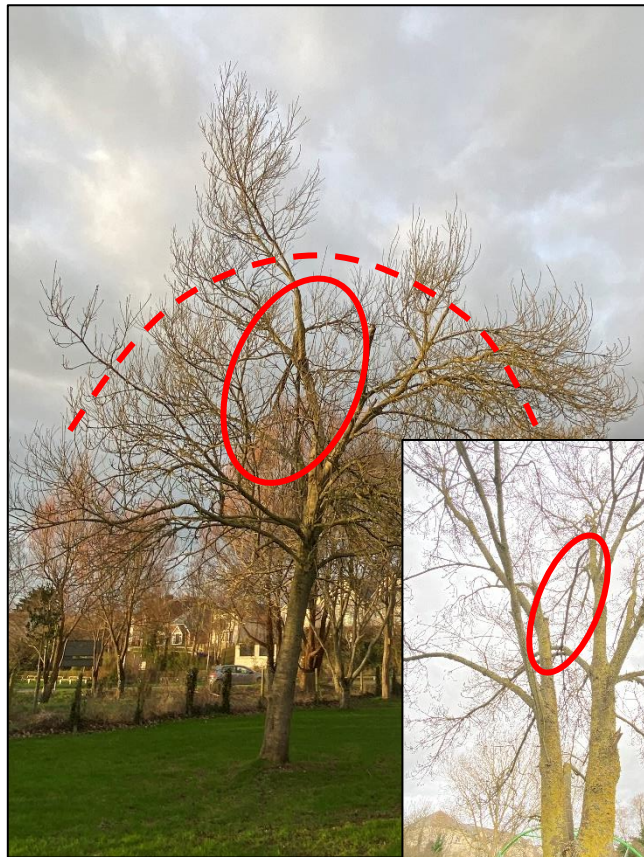
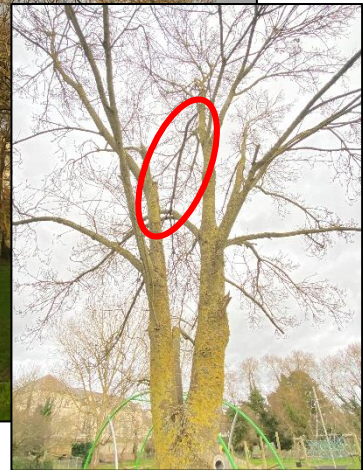
<b>Tree Number:</b>	1715	<b>Species:</b>	Ash
<b>Age Range:</b>	Middle Aged	<b>Height:</b>	Medium
<b>Life Expectancy:</b>	Medium	<b>Tree Condition:</b>	Fair
<b>Site Features:</b>	Tree overhangs path to children's play area		
<b>Comments:</b>	<ul style="list-style-type: none"> <li>• Individual specimen located adjacent footpath</li> <li>• Large split and hanging leading stem lodged within the top of the crown with parent stem compromised due to evidence of historic tear out</li> <li>• Evidence of other historic stem failures also present</li> <li>• Significant vertical epicormic growth suggesting possible ADD infection</li> <li>• Neighbouring Ash tree (untagged) to the west also has minor hanging branch within crown</li> </ul>		
<b>Hazard Rating:</b>	Medium		
<b>Recommendations:</b>	<ul style="list-style-type: none"> <li>• Remove hanging limb (identified with red oval in large photograph attached)</li> <li>• Reduce remaining crown by 2.0-3.0m to prevent exposure and future limb failures (indicative pruning line identified with dashed red line)</li> <li>• Remove minor hanging limb within crown of neighbouring Ash (identified in small picture with red oval)</li> </ul>

<b>Works Priority:</b>	2

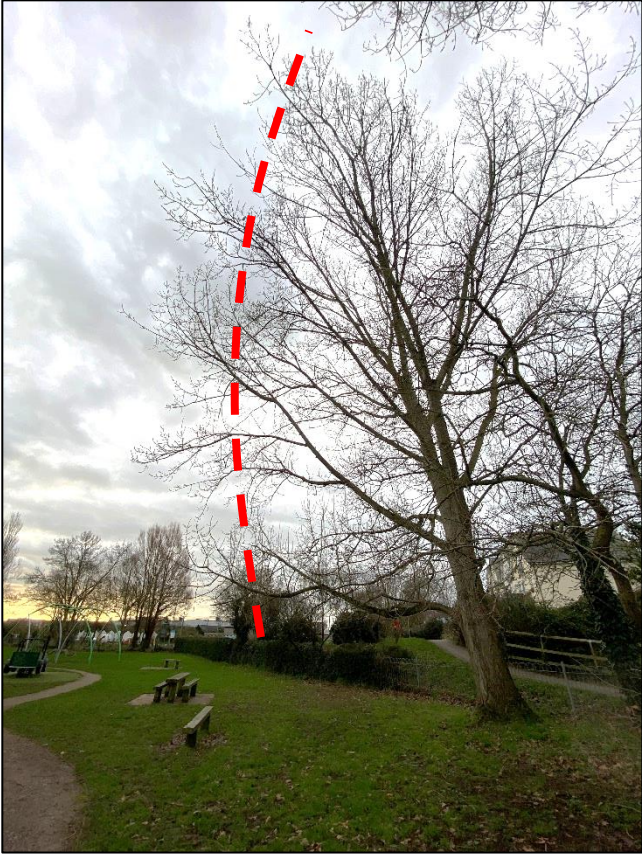
<b>Tree Number:</b>	1716	<b>Species:</b>	Poplar
<b>Age Range:</b>	Middle Aged	<b>Height:</b>	High
<b>Life Expectancy:</b>	Medium	<b>Tree Condition:</b>	Fair
<b>Site Features:</b>	Tree located next to children's play park and public footpath		
<b>Comments:</b>	<ul style="list-style-type: none"><li>• Southernmost stem of a pair of Poplars within this location</li><li>• Heavily loaded limbs overhanging picnic benches</li><li>• Species prone to branch failure</li></ul>		
<b>Hazard Rating:</b>	Medium		
<b>Recommendations:</b>	Reduce lower eastern aspect of crown by 2.0-3.0m as per indicative red dashed line in attached photograph. Maximum diameter of cuts 75mm		
<b>Works Priority:</b>	3		
<b>Photograph:</b>

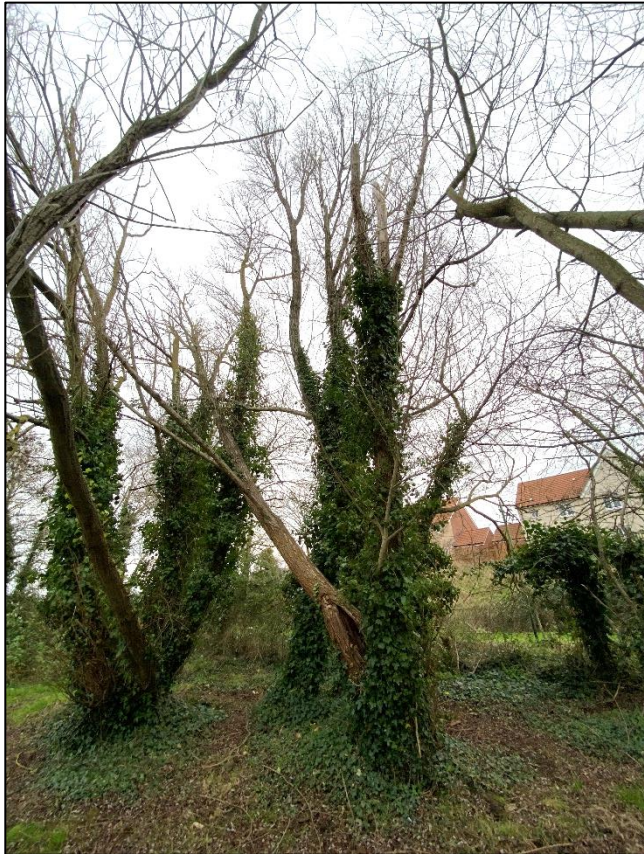
<b>Tree Number:</b>	1717	<b>Species:</b>	Willow x 2
<b>Age Range:</b>	Mature	<b>Height:</b>	Medium
<b>Life Expectancy:</b>	Low	<b>Tree Condition:</b>	Poor
<b>Site Features:</b>	Tree bound open grassed area and tram line		
<b>Comments:</b>	<ul style="list-style-type: none"> <li>• Pair of multi-stemmed Willow specimens</li> <li>• Southern tree hosts a failed stem which is hung up in the northernmost tree</li> <li>• Dieback exhibited in both stems</li> <li>• Tall etiolated form now becoming exposed and vulnerable to the elements</li> <li>• Both trees are reaching the end of their safe useful life</li> <li>• Poor basal unions present</li> </ul>		
<b>Hazard Rating:</b>	Medium		
<b>Recommendations:</b>	<ul style="list-style-type: none"> <li>• Remove failed stem</li> <li>• Reduce both trees to monoliths of approximately 5.0-8.0m</li> </ul>		
<b>Works Priority:</b>	2		
<b>Photograph:</b>

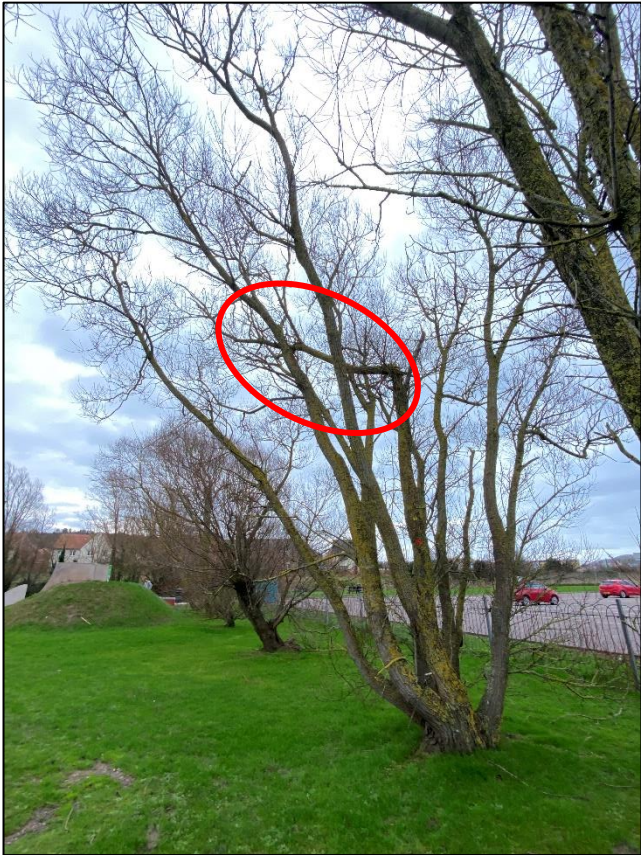
<b>Tree Number:</b>	1718	<b>Species:</b>	Willow
<b>Age Range:</b>	Young	<b>Height:</b>	Medium
<b>Life Expectancy:</b>	Medium	<b>Tree Condition:</b>	Fair
<b>Site Features:</b>	Tree adjacent children's play equipment and car park		
<b>Comments:</b>	<ul style="list-style-type: none"> <li>• Tall, etiolated multi-stemmed specimen</li> <li>• Tree hosts a failed central leading stem which is hung up in a neighbouring stem</li> <li>• Failed central stem has now exposed neighbouring stems and rendered them vulnerable to wind damage</li> </ul>		
<b>Hazard Rating:</b>	Medium		
<b>Recommendations:</b>	<ul style="list-style-type: none"> <li>• Remove failed hanging stem (identified within red oval)</li> <li>• Reduce remaining newly exposed crown by 2.0-3.0m, with maximum diameter of cuts being 75mm to minimise further risk of failure</li> </ul>		
<b>Works Priority:</b>	2		
<b>Photograph:</b>

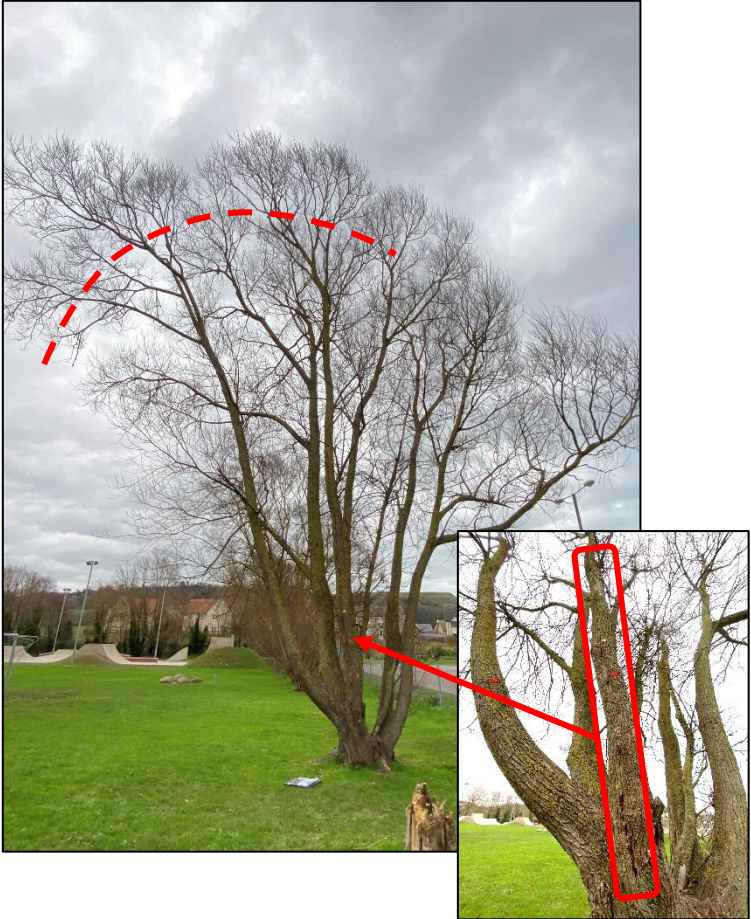
<b>Tree Number:</b>	1719	<b>Species:</b>	Willow
<b>Age Range:</b>	Middle Aged	<b>Height:</b>	Medium
<b>Life Expectancy:</b>	Low	<b>Tree Condition:</b>	Fair
<b>Site Features:</b>	Tree growing adjacent entrance to park and car park		
<b>Comments:</b>	<ul style="list-style-type: none"><li>• Tall, etiolated multi-stemmed specimen</li><li>• Some minor deadwood present</li><li>• Western stem exhibiting longitudinal bark dysfunction from ground level</li></ul>		
<b>Hazard Rating:</b>	Medium		
<b>Recommendations:</b>	<ul style="list-style-type: none"><li>• Reduce in height to two marked stems by 2.0m, maximum diameter of cuts 75mm, to reduce possibility of failure</li></ul>		
<b>Works Priority:</b>	3		
<b>Photograph:</b>

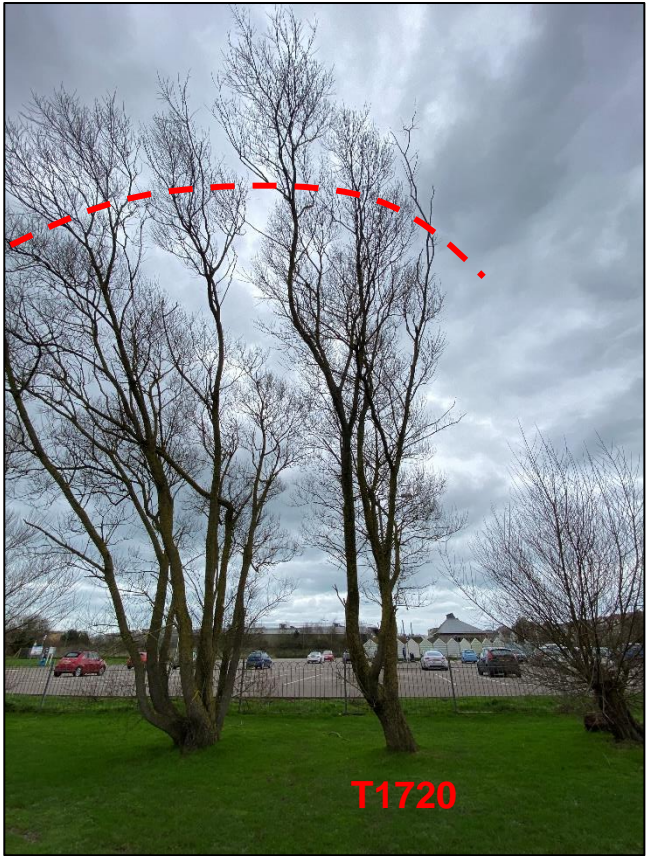
<b>Tree Number:</b>	1720	<b>Species:</b>	Willow
<b>Age Range:</b>	Middle Aged	<b>Height:</b>	Medium
<b>Life Expectancy:</b>	Low	<b>Tree Condition:</b>	Fair
<b>Site Features:</b>	Tree adjacent children's play equipment		
<b>Comments:</b>	<ul style="list-style-type: none"> <li>• Tall, etiolated multi-stemmed specimen</li> <li>• Tree located directly west of Willow T1718</li> <li>• Exposed tops of tree may become subject to failure as a result of neighbouring tree crown height reduction</li> <li>• Deadwood present</li> </ul>		
<b>Hazard Rating:</b>	Medium		
<b>Recommendations:</b>	Reduce the height of the tree to match Willow T1718; approximately 2.0m reduction with 60mm maximum diameter cuts		
<b>Works Priority:</b>	3		
<b>Photograph:</b>

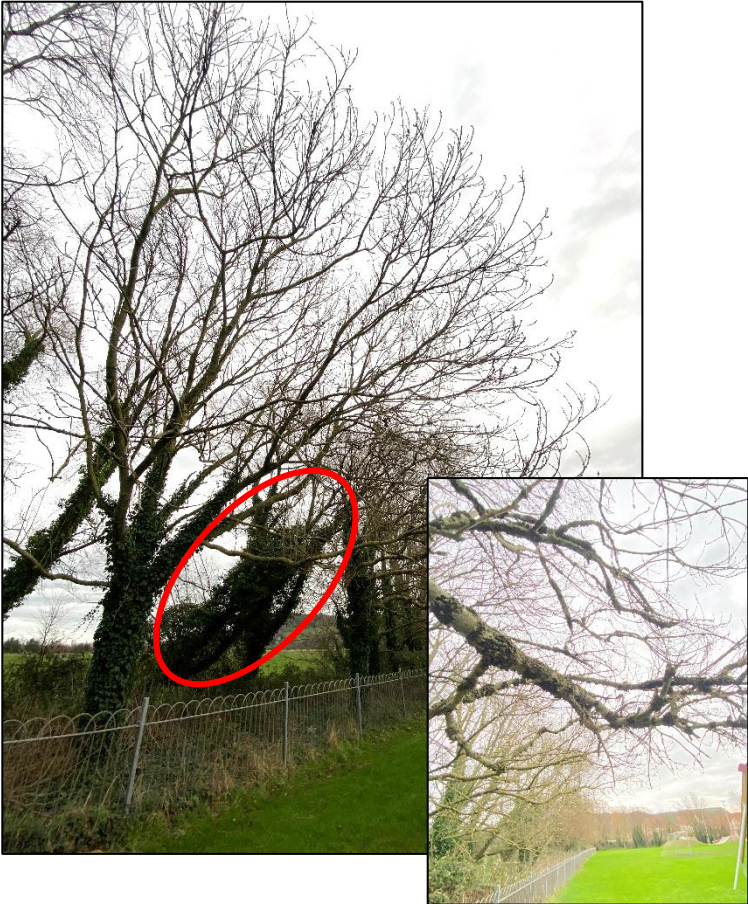
<b>Tree Number:</b>	Area A1	<b>Species:</b>	Willow, Ash
<b>Age Range:</b>	Young – Middle Aged	<b>Height:</b>	Low – High
<b>Life Expectancy:</b>	Low – Medium	<b>Tree Condition:</b>	Poor – Fair
<b>Site Features:</b>	Overhang play park		
<b>Comments:</b>	<ul style="list-style-type: none"> <li>• An area of neighbouring trees along the northern boundary</li> <li>• Multiple leaning, etiolated stems with evidence of possible windthrow within (red oval)</li> <li>• Excessive Ivy impeding any main stem of basal inspections</li> <li>• Significantly cankered Ash limbs overhanging into the play area</li> </ul>		
<b>Hazard Rating:</b>	Medium		
<b>Recommendations:</b>	Inform the owner of these trees there are some features which may be deemed a hazard. We recommend these trees are inspected by a suitably experienced and qualified arboriculturist after post Ivy and undergrowth removal		
<b>Works Priority:</b>	2
